**Flood Control Project Maintenance  
Levee Inspections**  
**LMA District Cover Sheet**  
**Spring 2019 Levee Inspection Results**

**Reclamation District No. 1500 Sutter Basin**

**Spring 2019 Levee Inspection Results**

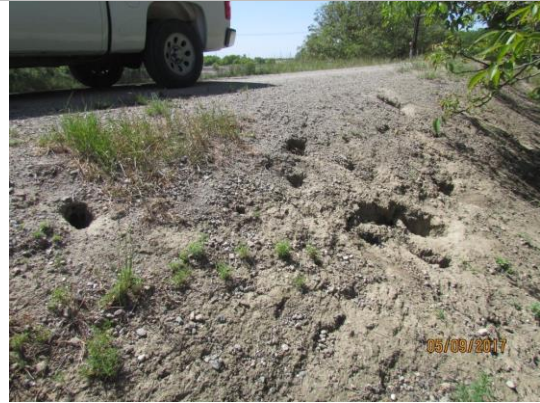
Photo 1 of 1 : SP\_2019\_RD1500\_189\_152\_20190304\_00079.jpg

LM Start	0.29	Rating **	M	Issue No.	152
LM End	0.29	Issue Type +	Ma	Location *	LS
Category	Earthen Levee			GPS Latitude/Longitude	
				Start	End
Item	Animal Control			38.762945 °	38.762945 °
				-121.678812 °	-121.678812 °
DWR ID	DWR_RD1500_01_f_2018_152				
Comment Code					
A3 : No rodents visible, but rodent burrows visible; need to backfill and compact or grout burrows.					
Inspector Comment					
There are multiple holes on the the landside slope.

View of rodent holes on landside slope. Spring 2017.

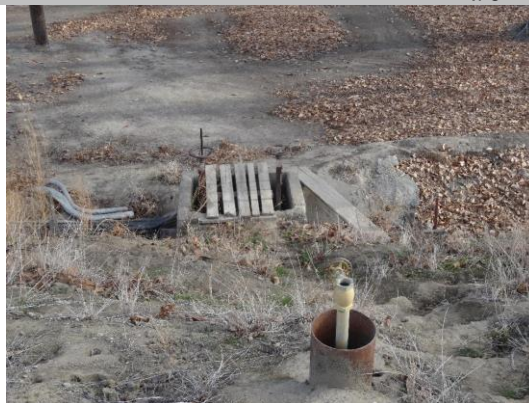
Photo 2 of 3 : UCIP\_SP\_2019\_28183\_51844.jpg

Comment Code						
Inspector Comment						
FS_ID:28183 DS_ID:20032 EP_NO: 1566A Repair Type: Non-Urgent Crossing Status: Found UCIP Comments: - soil erosion around headwall on waterside.- pump was removed.- overhead powerline. FIELD_STRUCT_DESC: *REPLACEMENT CROSSING* 10-inch coated steel irrigation discharge pipe through the levee, 5 feet below the crown. Pump and switch panel on the waterside (WS) berm. Service pole on WS shoulder. Siphon breaker on the landside (LS) slope. 3-foot by 4-foot concrete distribution box at the LS toe. (Replacement of an existing pipeline through the levee authorized under Permit No. 1566-A, 1980 - Ralph White Jr.). [Additional Reference(s): DWR Levee Log, 2005. USACE Sacramento O&M Manual 128, March 1960, (HLM 0.30), 8-inch pipe referenced]. FS Date: 1/9/2014

LS view: pressure breaker (bottom) in steel pipe riser and concrete distribution box on levee toe.

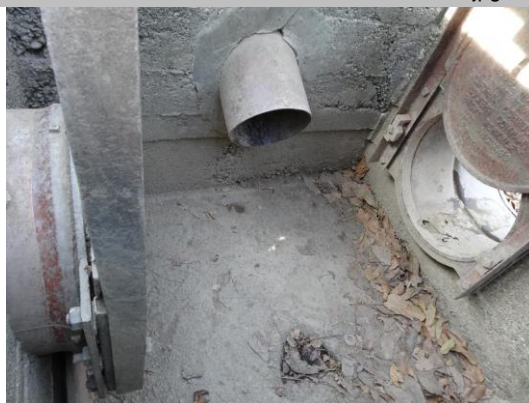
Photo 3 of 3 : UCIP\_SP\_2019\_28183\_51843.jpg

LS view: open steel pipe in concrete distribution box on levee toe.

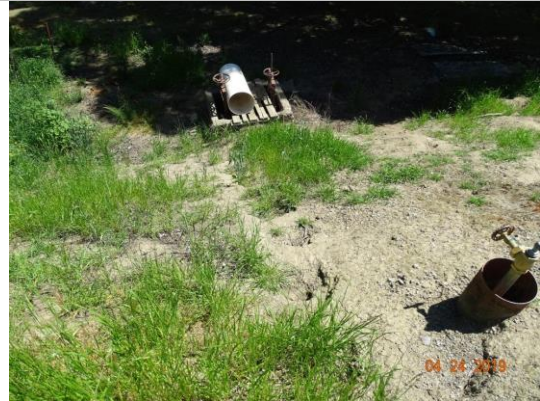
Photo 1 of 1 : SP\_2019\_RD1500\_189\_145\_20190424\_00222.jpg

LM Start	0.31	Rating **	M	Issue No.	145
LM End	0.31	Issue Type +	En	Location *	LS
Category	Earthen Levee			GPS Latitude/Longitude	
				Start	End
Item	Encroachments			38.763230 °	38.763230 °
				-121.679014 °	-121.679014 °
DWR ID	DWR_RD1500_01_f _ 2018_145				
Comment Code					
ST : Stairway					
Inspector Comment					
Stairs are dug into the landside slope.

View of stairs on the landside slope. Spring 2019.

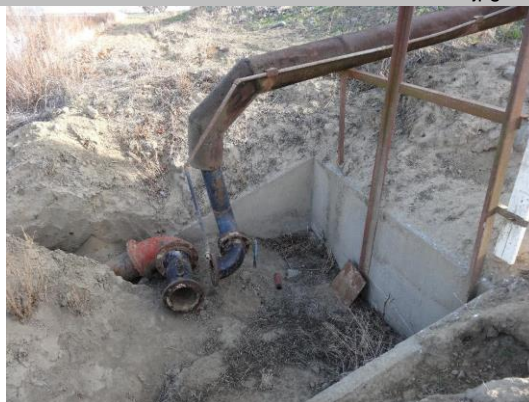
Photo 2 of 3 : UCIP\_SP\_2019\_28903\_53161.jpg

Comment Code					
Inspector Comment					
FS_ID:28903 DS_ID:20094 EP_NO: 10080 Repair Type: Non-Urgent Crossing Status: Found UCIP Comments: Pump removed from concrete pad and kept inside pump house (may be for storage purpose) on waterside.A 8-inch steel pipe inside 14-inch pipe. FIELD_STRUCT_DESC: 1 of 2: 14-inch steel irrigation discharge pipe through the levee, 5.2 feet below the crown. Pump in a corrugated metal pump house on the waterside (WS) slope. Butterfly valve on the WS. Concrete staircase on the WS slope. 1.75-inch galvanized iron water line with faucet exposed on the landside (LS) slope, 3.4 feet below the crown. 4-foot by 5.7-foot concrete distribution box at the LS toe. 1.25-inch conduit through levee, 2 feet below the crown. (14-inch steel irrigation discharge pipe through the levee and pump in a corrugated metal pump house on the WS slope authorized under Automatic Board Order (ABO) issued as Permit No. 10080, 1974 - Sebastian Yturralde). [Additional Reference(s): DWR Levee Log, 2005. USACE Sacramento O&M Manual 128, March 1960, (HLM 1.28)]. FS Date: 1/9/2014

WS view: U type headwall and 8-inch pipe sleeved into 14-inch steel pipe. Pump was removed from the pipe.

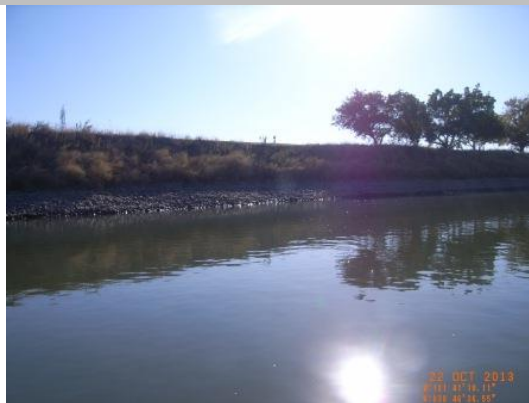
Photo 1 of 1 : SP\_2019\_RD1500\_189\_85\_20190304\_00037.jpg

LM Start	1.34	Rating **	A/W	Issue No.	85
LM End	1.95	Issue Type +	Ma	Location *	WS
Category	Supplemental			GPS Latitude/Longitude	
				Start	End
Item	2017 USACE Erosion Survey, DRAFT			38.770390 °	38.777282 °
				-121.690553 °	-121.685841 °
DWR ID	DWR_RD1500_01_f_2018_85				
Comment Code					
Inspector Comment					
2017 Site ID: SAC 86.3 L Status: Eroding 2017 Field Notes: No observed change.. Site History: 2006 - New erosion upstream, new bank failures near levee but still fairly wide berm in most places. 2008 - Large berm, questionable as to if it should remain in the inventory. 2010 - Minor new erosion, old cobble starting to fail. 2011 - Cobble continues to unravel and additional slumping. 2012 - Minor new erosion at bank mid point. 2013 - Minor new erosion. 2016 - Toe relatively stable. Upper slope is over steepened.

USACE 2013 Photo #1

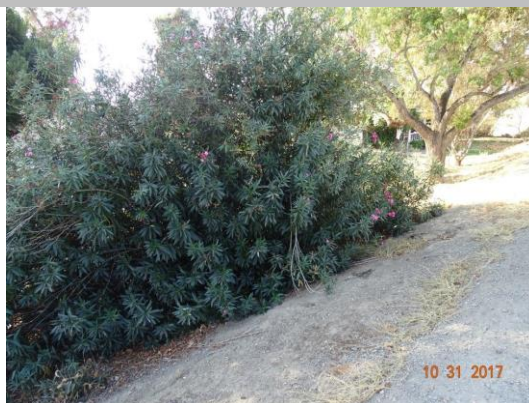
Photo 1 of 1 : SP\_2019\_RD1500\_189\_98\_20190304\_00046.jpg

LM Start	1.35	Rating **	M	Issue No.	98
LM End	1.35	Issue Type +	En	Location *	LS
Category	Earthen Levee			GPS Latitude/Longitude	
				Start	End
Item	Vegetation			38.770142 °	38.770142 °
				-121.690178 °	-121.690178 °
DWR ID	DWR_RD1500_01_f_2017_98				
Comment Code					
V6 : Landscaping					
Inspector Comment					
An oleander bush is partially blocking the landside slope.

View of vegetation on landside slope. Fall 2017.

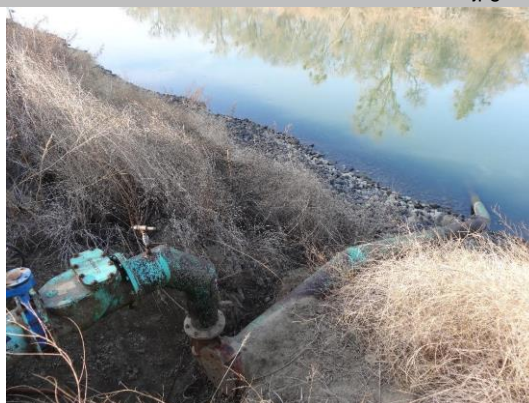
Photo 2 of 3 : UCIP\_SP\_2019\_28204\_51874.jpg

Comment Code						
Inspector Comment						
FS_ID:28204 DS_ID:20033 EP_NO: N/A Repair Type: Non-Urgent Crossing Status: Found UCIP Comments: - pump removed- erosion around pump station.- overhead electrical line. FIELD_STRUCT_DESC: 10-inch steel irrigation discharge pipe through the levee, 10 feet below the crown. Pump and gate valve on the riverbank. Service pole and switch panel on the waterside (WS) shoulder. Pipe crosses irrigation ditch and discharges into a steel distribution box in the field. (10-inch steel irrigation discharge pipe through the levee and pump on the riverbank authorized under Automatic Board Order (ABO) issued as Permit No. 10043, 1974 - Leo Giovanetti). [Additional Reference(s): DWR Levee Log, 2005. USACE Sacramento O&M Manual 128, March 1960, (HLM 1.63)]. FS Date: 1/9/2014

WS view: pump (removed) and inlet pipe on river bank.

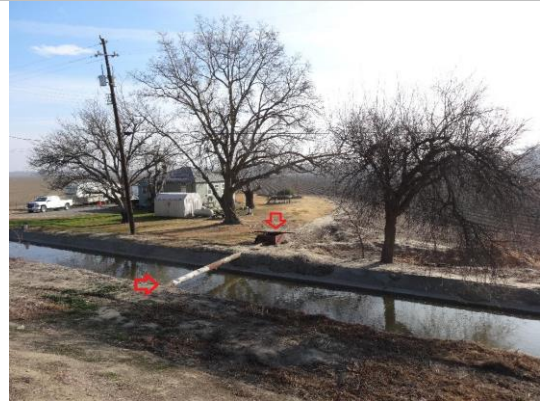
Photo 3 of 3 : UCIP\_SP\_2019\_28204\_51873.jpg

Comment Code						
Inspector Comment						
FS_ID:28204						
DS_ID:20033						
EP_NO: N/A						
Repair Type: Non-Urgent						
Crossing Status: Found						
UCIP Comments: - pump removed- erosion around pump station.- overhead electrical line.						
FIELD_STRUCT_DESC: 10-inch steel irrigation discharge pipe through the levee, 10 feet below the crown. Pump and gate valve on the riverbank. Service pole and switch panel on the waterside (WS) shoulder. Pipe crosses irrigation ditch and discharges into a steel distribution box in the field. (10-inch steel irrigation discharge pipe through the levee and pump on the riverbank authorized under Automatic Board Order (ABO) issued as Permit No. 10043, 1974 - Leo Giovanetti). [Additional Reference(s): DWR Levee Log, 2005. USACE Sacramento O&M Manual 128, March 1960, (HLM 1.63)].						
FS Date: 1/9/2014

LS view: pipe crosses irrigation ditch. Steel distribution box across irrigation ditch.

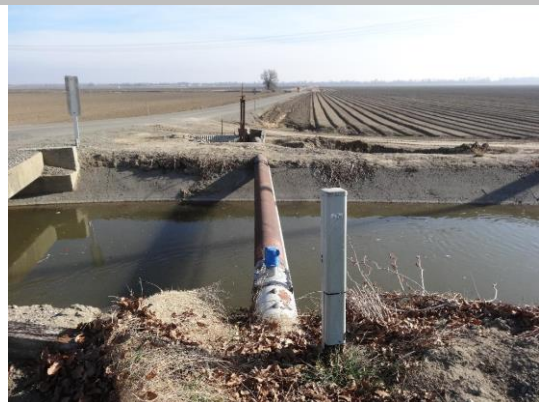
Photo 3 of 3 : UCIP\_SP\_2019\_28263\_51963.jpg

Comment Code						
Inspector Comment						
FS_ID:28263 DS_ID:20034 EP_NO: 16146 Repair Type: Non-Urgent Crossing Status: Found UCIP Comments: - pump removed- overhead powerline- pile structure abandoned- levee slope erosion due to leaky siphon breaker on landside. FIELD_STRUCT_DESC: *REPLACEMENT CROSSING* 12-inch steel irrigation discharge pipe through the levee, 12 feet below the crown. Pump mounted on the riverbank. Butterfly valve on the waterside (WS). Power pole with one anchor on the WS slope. Pipe discharges into a 5-foot by 5-foot damaged concrete distribution box across the irrigation ditch on the landside (LS). Electrical conduit through the levee. (Cat. I - Furlan). (Abandonment-in-place of an existing pipe and replacement of approximately 70 feet of 12-inch irrigation discharge pipe authorized under Permit No. 16146, 1993 - Antonio Furlan and Joe Schreiner). [Additional Reference(s): DWR Levee Log, 2005. USACE Sacramento O&M Manual 128, March 1960, (HLM 1.96)]. FS Date: 1/9/2014

LS view: discharge pipe crossing irrigation ditch.

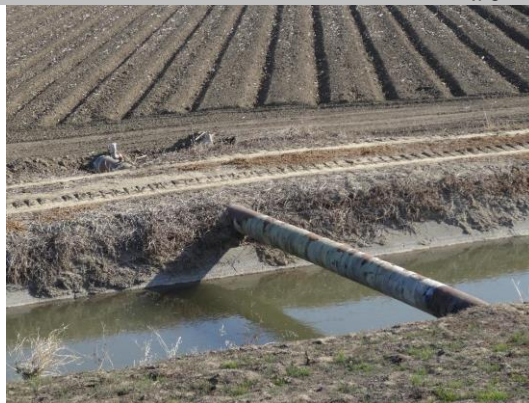
Photo 2 of 3 : UCIP\_SP\_2019\_28264\_51970.jpg

Comment Code						
Inspector Comment						
FS_ID:28264 DS_ID:20035 EP_NO: 10029 Repair Type: Non-Urgent Crossing Status: Found UCIP Comments: - pump removed- outlet plugged- looks abandoned. Found abandoned pipe parts on levee slope and berm.- overhead powerline FIELD_STRUCT_DESC: *ABANDONED* 12-inch steel irrigation discharge pipe through the levee, 11 feet below the crown. Two metal cutoff walls installed. Pumps on the riverbank during irrigation season. Gate valve at the waterside (WS) toe. Pipe discharges into a 2.5-foot by 2.5-foot concrete distribution box on the landside (LS) of the irrigation ditch. (Retention of a 12-inch steel irrigation discharge pipe through the levee and pumps on the riverbank during irrigation season authorized under Automatic Board Order (ABO) issued as Permit No. 10029, 1974 - Merle Anderson). [Additional Reference(s): DWR Levee Log, 2005. USACE Sacramento O&M Manual 128, March 1960, (HLM 2.40)]. FS Date: 1/9/2014

LS view: discharge pipe crossing irrigation ditch on landside.

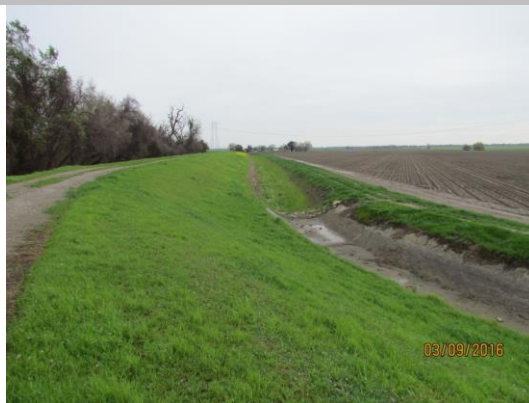
Photo 1 of 1 : SP\_2019\_RD1500\_189\_963\_20190304\_00082.jpg

LM Start	2.54	Rating **	M	Issue No.	963
LM End	3.68	Issue Type +	En	Location *	LS
Category	Earthen Levee			GPS Latitude/Longitude	
				Start	End
Item	Encroachments			38.785351 °	38.797128 °
				-121.689075 °	-121.691047 °
DWR ID	DWR_RD1500_01_s_2012_963				
Comment Code					
DT : Ditch					
Inspector Comment

View of the ditch at the toe of the landward side of the levee looking upstream. Spring 2016.

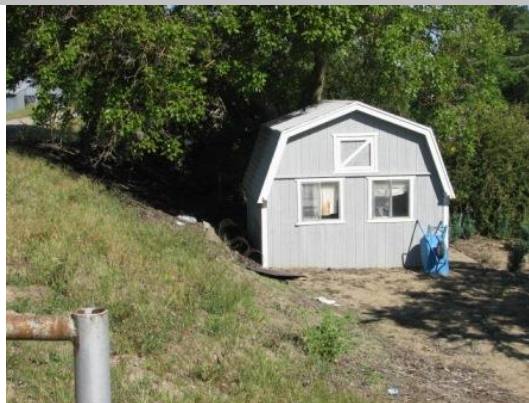
Photo 1 of 2 : SP\_2019\_RD1500\_189\_7\_20190304\_00002.jpg

LM Start	3.94	Rating **	U	Issue No.	7
LM End	3.94	Issue Type +	En	Location *	LS
Category	Earthen Levee			GPS Latitude/Longitude	
				Start	End
Item	Encroachments			38.797573 °	38.797573 °
				-121.695727 °	-121.695727 °
DWR ID	DWR_RD1500_01_s_2012_7				
Comment Code					
BU : Building					
Inspector Comment

A small building is encroaching into the landside levee toe.

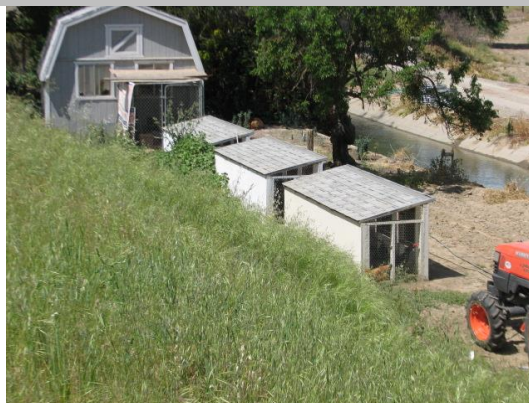
Photo 2 of 2 : SP\_2019\_RD1500\_189\_7\_20190304\_00003.jpg

Chicken coupes have been added along the toe of the levee. Spring

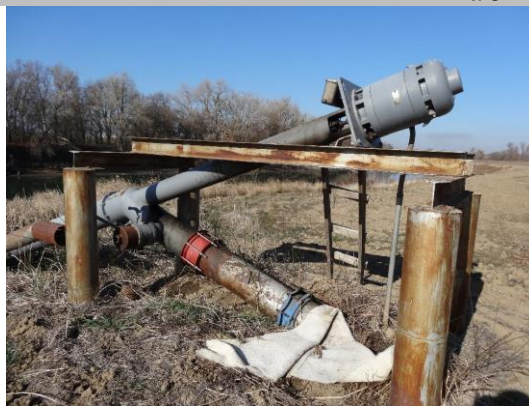
Photo 1 of 3 : UCIP\_SP\_2019\_28272\_52012.jpg

Comment Code						
Inspector Comment						
FS_ID:28272 DS_ID:20037 EP_NO: 3638 Repair Type: Non-Urgent Crossing Status: Found UCIP Comments: - No protection for pressure breaker. FIELD_STRUCT_DESC: 12-inch steel irrigation discharge pipe through the levee, 2.4 feet below the crown. Slant pump on the berm. Siphon breaker on the landside (LS) slope. Service pole at the LS toe. Pipe discharges into a 36-inch concrete standpipe on the LS. (Installation, maintenance, and operation of an inclined pump and an existing pipe to remain through the levee authorized under Permit No. 3638, 1961 - James F. Waters). [Additional Reference(s): DWR Levee Log, 2005. USACE Sacramento O&M Manual 128, March 1960, (HLM 4.04)]. FS Date: 1/9/2014

WS view: slant pump on steel frame on levee berm.

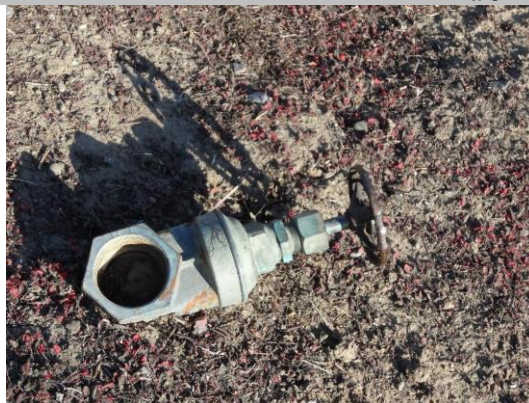
Photo 2 of 3 : UCIP\_SP\_2019\_28272\_52011.jpg

Comment Code						
Inspector Comment						
FS_ID:28272 DS_ID:20037 EP_NO: 3638 Repair Type: Non-Urgent Crossing Status: Found UCIP Comments: - No protection for pressure breaker. FIELD_STRUCT_DESC: 12-inch steel irrigation discharge pipe through the levee, 2.4 feet below the crown. Slant pump on the berm. Siphon breaker on the landside (LS) slope. Service pole at the LS toe. Pipe discharges into a 36-inch concrete standpipe on the LS. (Installation, maintenance, and operation of an inclined pump and an existing pipe to remain through the levee authorized under Permit No. 3638, 1961 - James F. Waters). [Additional Reference(s): DWR Levee Log, 2005. USACE Sacramento O&M Manual 128, March 1960, (HLM 4.04)]. FS Date: 1/9/2014

LS view: pressure breaker without protection on levee slope.

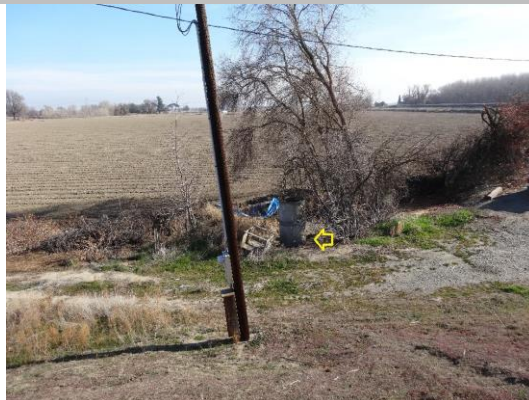
Photo 3 of 3 : UCIP\_SP\_2019\_28272\_52013.jpg

LS view: power pole and concrete standpipe on levee toe.

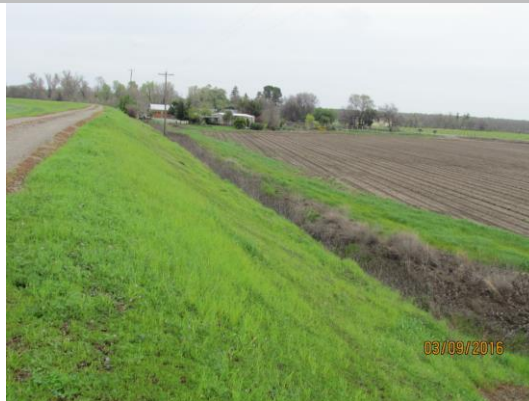
Photo 1 of 1 : SP\_2019\_RD1500\_189\_54\_20190304\_00025.jpg

LM Start	4.02	Rating **	M	Issue No.	54
LM End	4.12	Issue Type +	En	Location *	LS
Category	Earthen Levee			GPS Latitude/Longitude	
				Start	End
Item	Encroachments			38.798526 °	38.800063 °
				-121.696326 °	-121.696622 °
DWR ID	DWR_RD1500_01_s_2012_54				
Comment Code					
DT : Ditch					
Inspector Comment					
A ditch runs along the toe of the levee.

View of the ditch on the landward side of the levee looking upstream. Spring 2016.

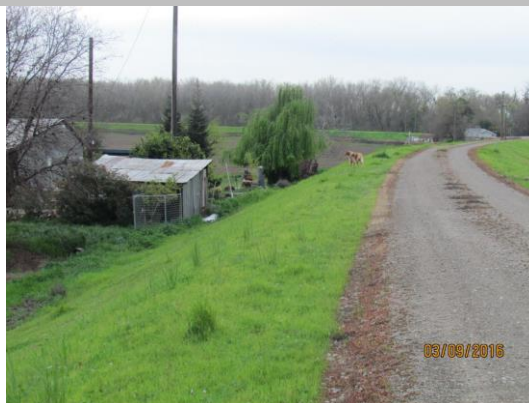
Photo 1 of 1 : SP\_2019\_RD1500\_189\_11\_20190304\_00006.jpg

LM Start	4.16	Rating **	M	Issue No.	11
LM End	4.16	Issue Type +	En	Location *	LS
Category	Earthen Levee			GPS Latitude/Longitude	
				Start	End
Item	Encroachments			38.800548 °	38.800548 °
				-121.696751 °	-121.696751 °
DWR ID	DWR_RD1500_01_s_2012_11				
Comment Code					
BU : Building					
Inspector Comment

View of the equipment shed on the landward side of the levee looking downstream. Spring 2016.

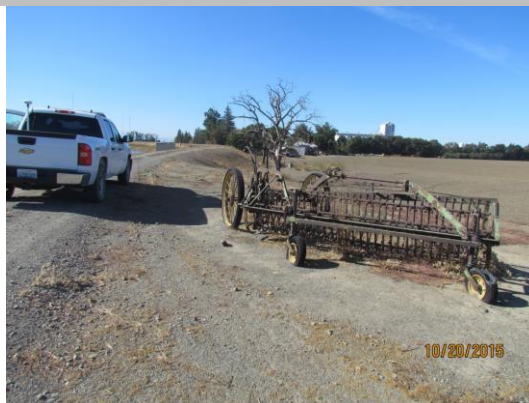
Photo 1 of 1 : SP\_2019\_RD1500\_189\_108\_20190304\_00052.jpg

LM Start	5.14	Rating **	M	Issue No.	108
LM End	5.14	Issue Type +	En	Location *	LS
Category	Earthen Levee			GPS Latitude/Longitude	
				Start	End
Item	Encroachments			38.801962 °	38.801962 °
				-121.712118 °	-121.712118 °
DWR ID	DWR_RD1500_01_f_2015_108				
Comment Code					
EQ : Equipment					
Inspector Comment

View of the equipment on the landward side of the levee looking upstream. Fall 2015.

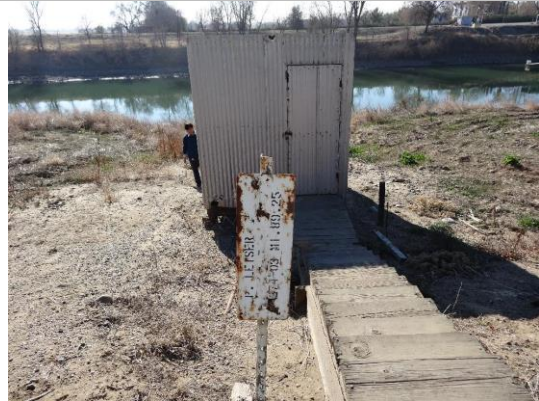
Photo 1 of 3 : UCIP\_SP\_2019\_28913\_53184.jpg

Comment Code					
Inspector Comment					
FS_ID:28913 DS_ID:20041 EP_NO: 10056 Repair Type: Non-Urgent Crossing Status: Found UCIP Comments: Depression on landside levee slope around siphon breaker due to leakage.Siphon breaker needs protection. FIELD_STRUCT_DESC: 18-inch steel irrigation discharge pipe through the levee, 4 feet below the crown. 1.5-inch conduit through the levee, 20 feet below the crown. Slant pump in a corrugated metal pump house on the waterside (WS). Wooden steps on the WS slope. Siphon breaker on the landside (LS) slope. 5-foot by 5-foot concrete distribution box at the LS toe. (18-inch steel irrigation discharge pipe and all other elements of this irrigation structure retained under Automatic Board Order (ABO) issued as Permit No. 10056, 1974 - Philip Leiser). [Additional Reference(s): DWR Levee Log, 2005. USACE Sacramento O&M Manual 128, March 1960, (HLM 5.23)]. FS Date: 1/9/2014

WS view: wooden steps to pump house on levee berm.

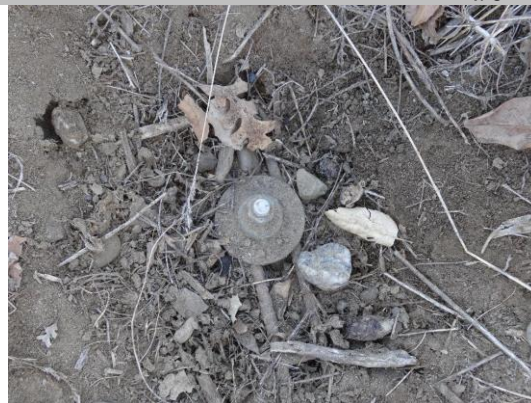
Photo 3 of 3 : UCIP\_SP\_2019\_28913\_53182.jpg

Comment Code						
Inspector Comment						
FS_ID:28913 DS_ID:20041 EP_NO: 10056 Repair Type: Non-Urgent Crossing Status: Found UCIP Comments: Depression on landside levee slope around siphon breaker due to leakage.Siphon breaker needs protection. FIELD_STRUCT_DESC: 18-inch steel irrigation discharge pipe through the levee, 4 feet below the crown. 1.5-inch conduit through the levee, 20 feet below the crown. Slant pump in a corrugated metal pump house on the waterside (WS). Wooden steps on the WS slope. Siphon breaker on the landside (LS) slope. 5-foot by 5-foot concrete distribution box at the LS toe. (18-inch steel irrigation discharge pipe and all other elements of this irrigation structure retained under Automatic Board Order (ABO) issued as Permit No. 10056, 1974 - Philip Leiser). [Additional Reference(s): DWR Levee Log, 2005. USACE Sacramento O&M Manual 128, March 1960, (HLM 5.23)]. FS Date: 1/9/2014

LS view: leaky and obstructed siphon breaker. Depression around siphon breaker due to leakage.

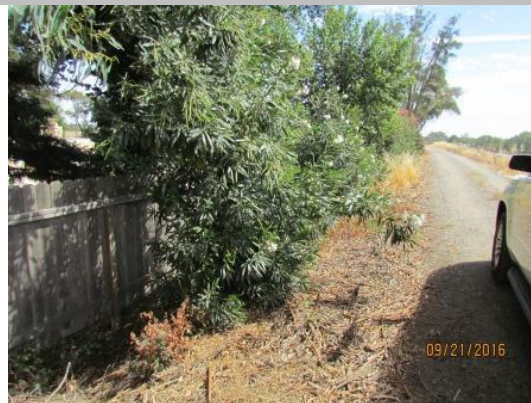
Photo 1 of 1 : SP\_2019\_RD1500\_189\_125\_20190304\_00069.jpg

LM Start	5.32	Rating **	U	Issue No.	125
LM End	5.35	Issue Type +	En	Location *	LS
Category	Earthen Levee			GPS Latitude/Longitude	
				Start	End
Item	Encroachments			38.803181 °	38.803344 °
				-121.715141 °	-121.715616 °
DWR ID	DWR_RD1500_01_f_2016_125				
Comment Code					
FE : Fence					
Inspector Comment

View of fence and vegetation on LS slope. Fall 2016.

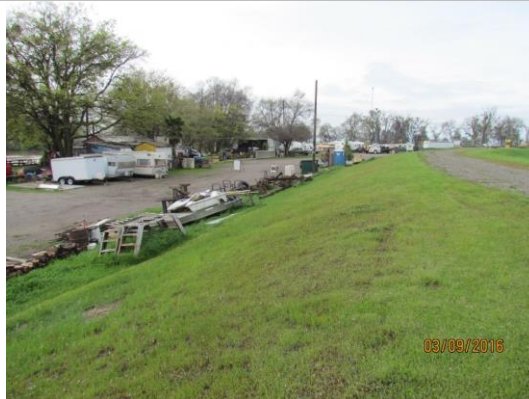
Photo 1 of 1 : SP\_2019\_RD1500\_189\_52\_20190304\_00024.jpg

LM Start	5.61	Rating **	M	Issue No.	52
LM End	5.69	Issue Type +	En	Location *	WS
Category	Earthen Levee			GPS Latitude/Longitude	
				Start	End
Item	Encroachments			38.803067 °	38.803238 °
				-121.720270 °	-121.721847 °
DWR ID	DWR_RD1500_01_s_2012_52				
Comment Code					
EQ : Equipment					
Inspector Comment					
Sting Rayz Beach Boardwalk Marina on the waterside berm should move equipment stored on levee toe away from levee.

View of equipment on waterside levee toe looking upstream. Spring 2016.

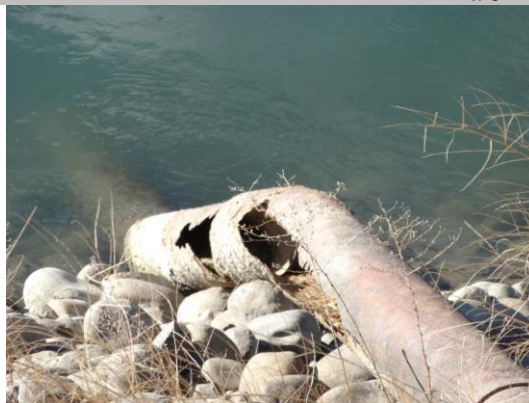
Photo 2 of 3 : UCIP\_SP\_2019\_28923\_53201.jpg

Comment Code						
Inspector Comment						
FS_ID:28923 DS_ID:20047 EP_NO: 10048 Repair Type: Non-Urgent Crossing Status: Found UCIP Comments: An abandoned pipe. Highly deteriorated pipe on river bank.Needs proper abandonment.Not found- Siphon breaker at landward levee toe. FIELD_STRUCT_DESC: *ABANDONED* 10-inch steel irrigation discharge pipe and a 1-inch conduit through the levee, 4.5 feet below the crown. Pump in a metal shed on the riverbank. Gate valve on the waterside (WS) end. Service pole and 24-inch concrete standpipe at the landside (LS) toe. Installed by USACE in 1958. (10-inch steel irrigation discharge pipe through the levee and all other appurtenances retained under Automatic Board Order (ABO) issued as Permit No. 10048, 1974 - Virgil J. King) [Additional Reference(s): DWR Levee Log, 2005. USACE Sacramento O&M Manual 128, March 1960, (HLM 7.22)]. FS Date: 1/9/2014

WS view: deteriorated and abandoned steel pipe on river bank.

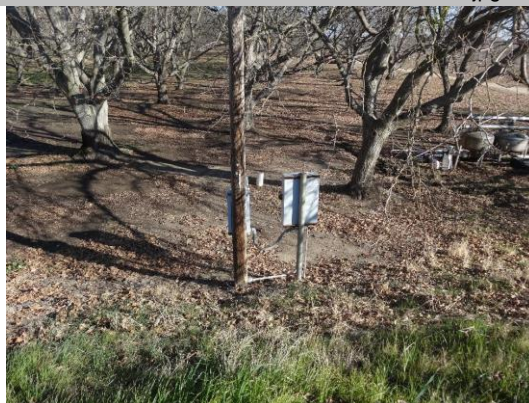
Photo 3 of 3 : UCIP\_SP\_2019\_28923\_53200.jpg

LS view: service pole and switch board on levee toe. No other appurtenances found on landside.

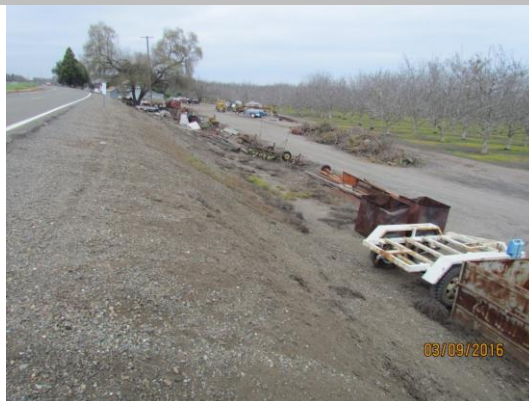
Photo 1 of 1 : SP\_2019\_RD1500\_189\_16\_20190304\_00007.jpg

LM Start	7.49	Rating **	M	Issue No.	16
LM End	7.49	Issue Type +	En	Location *	LS
Category	Earthen Levee			GPS Latitude/Longitude	
				Start	End
Item	Encroachments			38.828944 °	38.828944 °
				-121.724329 °	-121.724329 °
DWR ID	DWR_RD1500_01_f_2017_16				
Comment Code					
EQ : Equipment					
Inspector Comment

View of the equipment along the levee toe on the landward side of the levee looking upstream. Spring 2016.

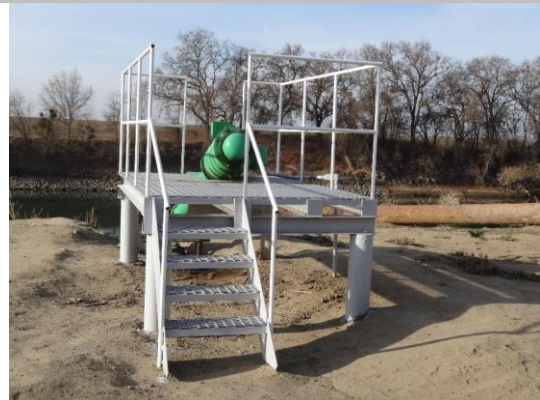
Photo 1 of 3 : UCIP\_SP\_2019\_50199\_53204.jpg

Comment Code						
Inspector Comment						
FS_ID:50199 DS_ID:20049 EP_NO: 8147 Repair Type: Non-Urgent Crossing Status: Found UCIP Comments: 08/29/2016: New pumps installed at LS toe ditch, could not find permit for this work. No signs of leakage or excessive vegetation growth in alignment with the pipe. Riser silted in; recommend installing a lid. Crossing has been downgraded from Urgent to Non-Urgent. (K. Fazel - UCIP)01/10/2014:Not found- slide gate in 48-inch corrugated metal riser at waterside toe.Repair works under way. Contact LMA for repair works information.Sign of leaky pipe and siphon breaker. This needs detailed investigation. (P. Amatya - DWR) FIELD_STRUCT_DESC: 12-inch steel irrigation discharge pipe through the levee, 4.8 feet below the crown. Slant pump mounted on a steel structure at the riverbank. 4-foot by 4-foot concrete distribution box at the landside (LS) toe with newly installed pumps with shutoff valves. (Replacement of a discharge pipe through the levee with a new 12-inch steel discharge pipe authorized under Permit No. 8147, 1972 - J. A. Driver). [Additional Reference(s): DWR Levee Log, 2005. USACE Sacramento O&M Manual 128, March 1960, (HLM 7.79)]. FS Date: 8/29/2016

WS view: slant pump on steel platform on end of berm.

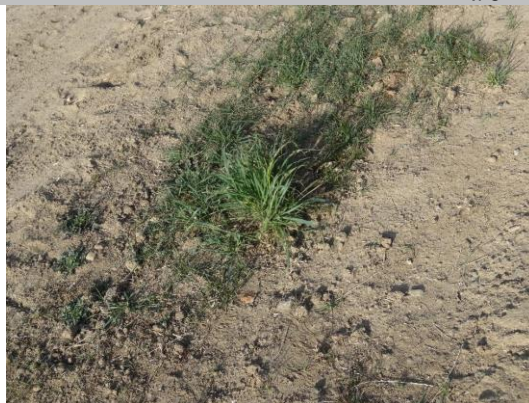
Photo 2 of 3 : UCIP\_SP\_2019\_50199\_53203.jpg

Comment Code						
Inspector Comment						
FS_ID:50199 DS_ID:20049 EP_NO: 8147 Repair Type: Non-Urgent Crossing Status: Found UCIP Comments: 08/29/2016: New pumps installed at LS toe ditch, could not find permit for this work. No signs of leakage or excessive vegetation growth in alignment with the pipe. Riser silted in; recommend installing a lid. Crossing has been downgraded from Urgent to Non-Urgent. (K. Fazel - UCIP)01/10/2014:Not found- slide gate in 48-inch corrugated metal riser at waterside toe.Repair works under way. Contact LMA for repair works information.Sign of leaky pipe and siphon breaker. This needs detailed investigation. (P. Amatya - DWR) FIELD_STRUCT_DESC: 12-inch steel irrigation discharge pipe through the levee, 4.8 feet below the crown. Slant pump mounted on a steel structure at the riverbank. 4-foot by 4-foot concrete distribution box at the landside (LS) toe with newly installed pumps with shutoff valves. (Replacement of a discharge pipe through the levee with a new 12-inch steel discharge pipe authorized under Permit No. 8147, 1972 - J. A. Driver). [Additional Reference(s): DWR Levee Log, 2005. USACE Sacramento O&M Manual 128, March 1960, (HLM 7.79)]. FS Date: 8/29/2016

WS view: sign of leakage- excessive vegetation on levee slope.

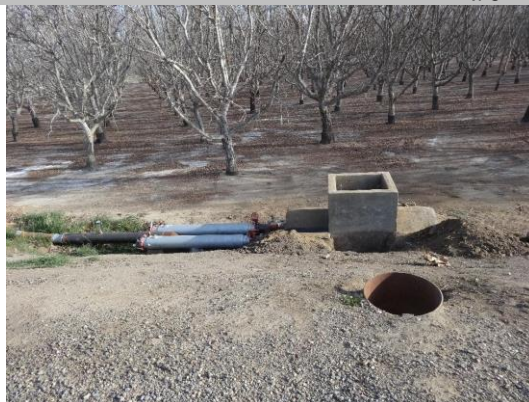
Photo 3 of 3 : UCIP\_SP\_2019\_50199\_53207.jpg

LS view: steel riser with siphon breaker (bottom) and concrete distribution box on levee toe (top).

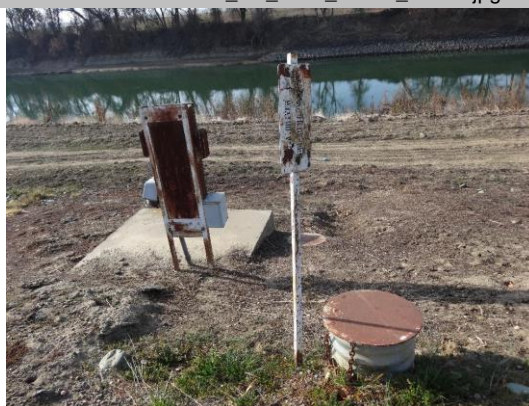
Photo 1 of 3 : UCIP\_SP\_2019\_28323\_52125.jpg

Comment Code					
Inspector Comment					
FS_ID:28323 DS_ID:20051 EP_NO: 13882 Repair Type: Non-Urgent Crossing Status: Found UCIP Comments: Power pole on landside. 2-inch conduit through the levee. Service box on waterside. Concrete pad on waterside. Not found- Concrete distribution box on landward side; not found- gate valve on waterside. Need proper abandonment. Pipe visible on river bank, waterside levee slope and landside field. FIELD_STRUCT_DESC: *ABANDONED* 6-inch steel irrigation discharge pipe through the levee, 4.9 feet below the crown. 12-inch steel irrigation discharge pipe through the levee, 5 feet below the crown. 1.5-inch electrical conduit through the levee, 4 feet below the crown. Pump at the riverbank. Pump switch and gate valve on the waterside (WS) slope. Meter pole at the landside (LS) toe. Concrete distribution box on the LS. Installed by USACE in 1959. (6-inch steel irrigation discharge pipe through the levee and all other appurtenances retained under Automatic Board Order (ABO) issued as Permit No. 10062, 1974 - Pauline Moroni. Installation of a 12-inch steel pipe through the levee authorized under Permit No. 13882, 1984 - Ted A. Moroni). [Additional Reference(s): DWR Levee Log, 2005. USACE Sacramento O&M Manual 128, March 1960, (HLM 8.04)]. FS Date: 1/10/2014

WS view: CMP with air vent (right), concrete pad (left), and switch panel (left) on levee slope.

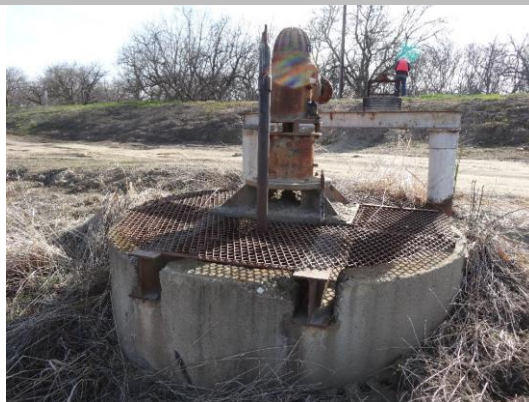
Photo 2 of 3 : UCIP\_SP\_2019\_28324\_52130.jpg

WS view: vertical pump on concrete sump on levee berm. Looks abandoned.

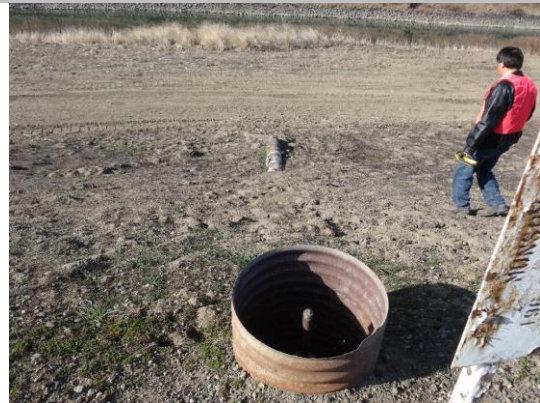
Photo 1 of 3 : UCIP\_SP\_2019\_28363\_52167.jpg

Comment Code						
Inspector Comment						
FS_ID:28363 DS_ID:20055 EP_NO: 8503 Repair Type: Non-Urgent Crossing Status: Found UCIP Comments: Looks abandoned. No pump found on WS.New well near landside.May need proper abandonment.Exposed pipe on waterside. Found steel plate closed pipe on landside. FIELD_STRUCT_DESC: *ABANDONED* 12-inch steel irrigation discharge pipe through the levee, 3.8 feet below the crown. Pump on concrete pad with headwall at the riverbank. Siphon breaker in a 24-inch corrugated metal pipe (CMP) riser on the waterside (WS) slope. 1.25-inch conduit through the levee, 3 feet below the crown. Meter pole with switch panel at the landside (LS) toe. Concrete distribution box at the LS toe. (12-inch steel irrigation discharge pipe through the levee and slant pump retained under Permit No. 8503, 1972 - James T. Munson). [Additional Reference(s): DWR Levee Log, 2005. USACE Sacramento O&M Manual 128, March 1960, (HLM 9.04), 10-inch pipe referenced]. FS Date: 1/10/2014

WS view: siphon breaker in CMP riser on levee slope.

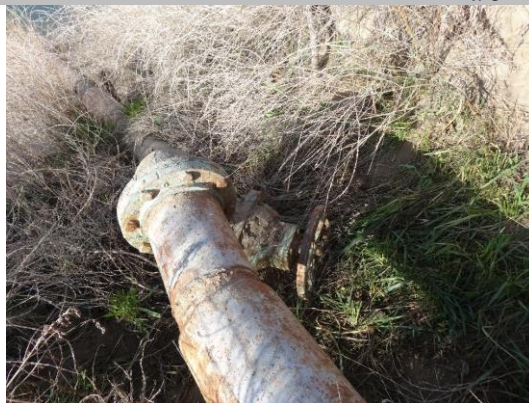
Photo 2 of 3 : UCIP\_SP\_2019\_28363\_52166.jpg

WS view: inlet steel pipe with gate valve on river bank.

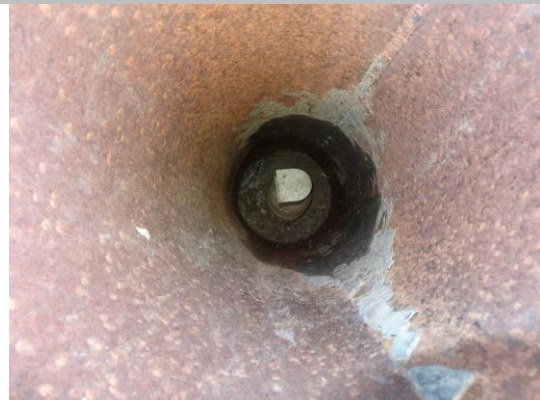
Photo 2 of 3 : UCIP\_SP\_2019\_28364\_52175.jpg

LS view: air vent in steel pipe riser on levee slope.

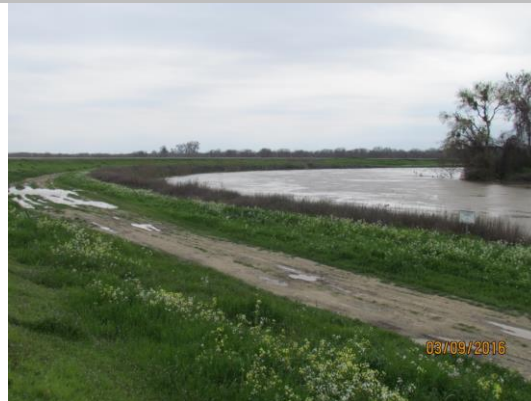
Photo 1 of 2 : SP\_2019\_RD1500\_189\_74\_20190304\_00029.jpg

LM Start	9.40	Rating **	A/W	Issue No.	74
LM End	9.57	Issue Type +	Ob	Location *	WS
Category	Earthen Levee			GPS Latitude/Longitude	
				Start	End
Item	Vegetation			38.850267 °	38.852564 °
				-121.723275 °	-121.723179 °
DWR ID	DWR_RD1500_01_s_2012_74				
Comment Code					
V8 : Environmental Requirements.					
Inspector Comment

View of the revegetation site along the edge of the berm on the waterward side of the levee looking downstream. Spring 2016.

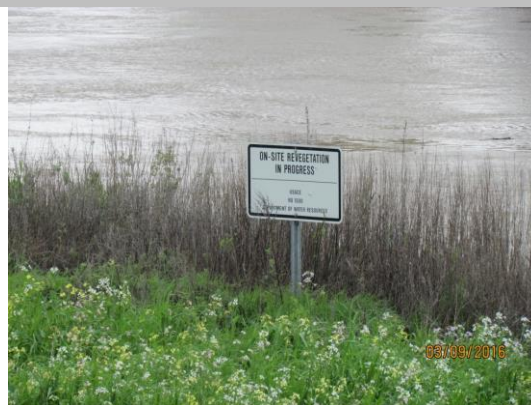
Photo 2 of 2 : SP\_2019\_RD1500\_189\_74\_20190304\_00030.jpg

Sign for the revegetation site by USACE.

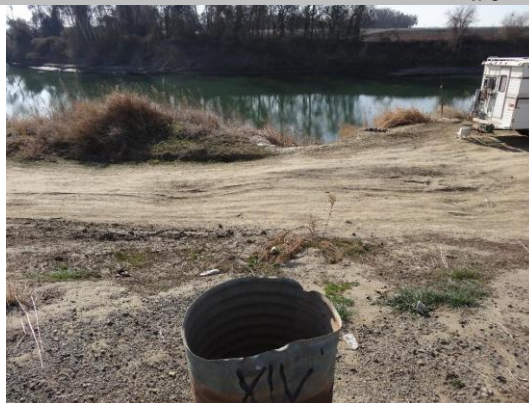
Photo 1 of 3 : UCIP\_SP\_2019\_28365\_52182.jpg

Comment Code						
Inspector Comment						
FS_ID:28365 DS_ID:20057 EP_NO: N/A Repair Type: Non-Urgent Crossing Status: Found UCIP Comments: Looks abandoned. Pump has been removed. No outlet pipe found. Not found- Wooden service panel and 3x5 foot concrete distribution box at landward shoulder.May need proper abandonment. FIELD_STRUCT_DESC: 14-inch steel irrigation discharge pipe through the levee, 4.2 feet below the crown. Pump and gate valve on a concrete pump platform on the bank. Siphon breaker in a 24-inch corrugated metal pipe (CMP) riser on the waterside (WS) shoulder. Wooden switch panel and pole on the WS slope. 3-foot by 5-foot concrete distribution box at the landside (LS) toe. (14-inch steel irrigation discharge pipe through the levee, pump, and all other appurtenances retained under Automatic Board Order (ABO) issued as Permit No. 10069, 1974 - Robert Reel). [Additional Reference(s): DWR Levee Log, 2005. USACE Sacramento O&M Manual 128, March 1960, (HLM 9.77)]. FS Date: 1/10/2014

WS view: CMP riser with siphon breaker on levee slope.

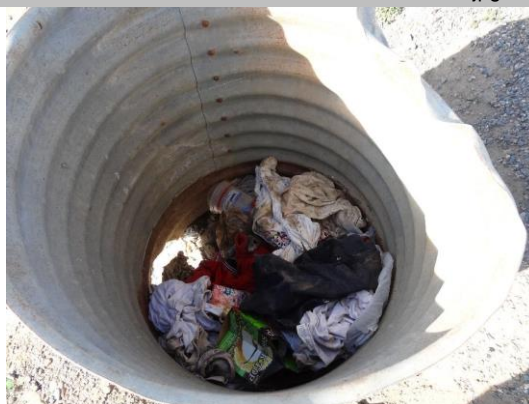
Photo 2 of 3 : UCIP\_SP\_2019\_28365\_52180.jpg

WS view: siphon breaker obstructed by dumped-trash in CMP riser.

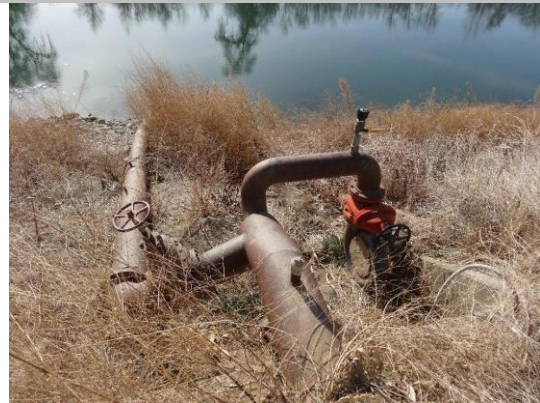
Photo 1 of 3 : UCIP\_SP\_2019\_28925\_53210.jpg

Comment Code					
Inspector Comment					
FS_ID:28925 DS_ID:20059 EP_NO: N/A Repair Type: Non-Urgent Crossing Status: Found UCIP Comments: Pump removed.Obstructed siphon breaker in CMP riser on landside. FIELD_STRUCT_DESC: 12-inch steel irrigation discharge pipe through the levee, 4.3 feet below the crown. One cutoff wall. 1.5-inch conduit through the levee, 2 feet below the crown. Slant type centrifugal pumping plant on the riverbank removed during the winter months and a steel plate is bolted to the end of the pipe. Gate valve on the waterside (WS). Siphon breaker in a 24-inch corrugated metal pipe (CMP) riser on the landside (LS) shoulder. 8-foot by 6-foot, inside measurements, concrete distribution box and meter pole with switch panel at the LS toe. (12-inch steel irrigation discharge pipe through the levee and slant type centrifugal pumping plant retained under Permit No. 8506, 1972 - Eugene C. Reel et al.). [Additional Reference(s): DWR Levee Log, 2005. USACE Sacramento O&M Manual 128, March 1960, (HLM 10.81)]. FS Date: 1/10/2014

WS view: pipe, pump (removed and plugged with plywood), headwall, and appurtenances on river bank.

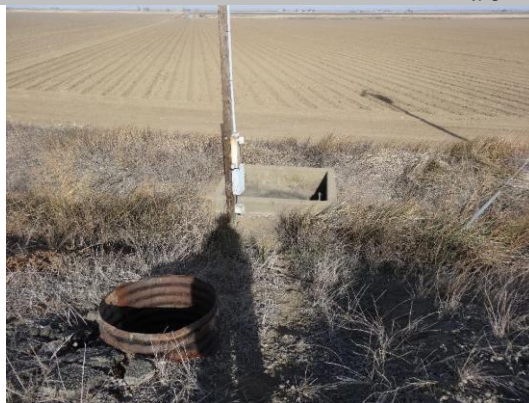
Photo 2 of 3 : UCIP\_SP\_2019\_28925\_53209.jpg

LS view: siphon breaker in CMP riser (bottom) on levee slope and concrete distribution box (top) on levee toe.

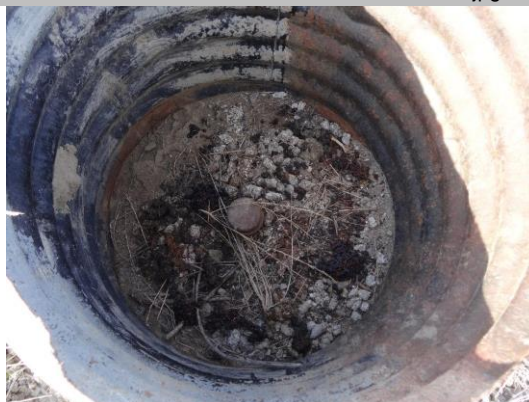
Photo 3 of 3 : UCIP\_SP\_2019\_28925\_53208.jpg

LS view: obstructed siphon breaker in CMP riser (bottom) on levee slope.

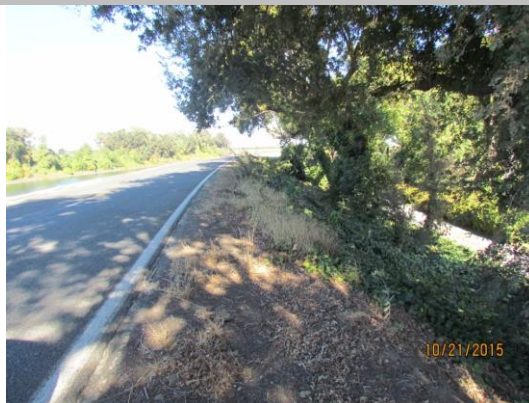
Photo 1 of 1 : SP\_2019\_RD1500\_189\_20\_20190304\_00009.jpg

LM Start	11.30	Rating **	M	Issue No.	20
LM End	11.30	Issue Type +	En	Location *	LS
Category	Earthen Levee			GPS Latitude/Longitude	
				Start	End
Item	Vegetation			38.866383 °	38.866383 °
				-121.745911 °	-121.745911 °
DWR ID	DWR_RD1500_01_s_2012_20				
Comment Code					
V6 : Landscaping					
Inspector Comment					
Permitted landscape needs maintenance. (PN: 10041)

View of the landscaping on the landward side of the levee looking upstream. Fall 2015.

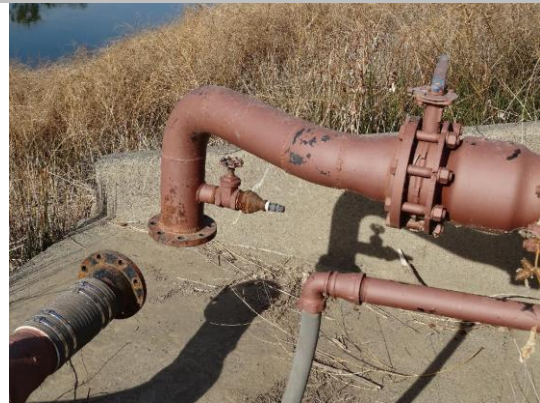
Photo 1 of 3 : UCIP\_SP\_2019\_50198\_52220.jpg

Comment Code						
Inspector Comment						
FS_ID:50198 DS_ID:20061 EP_NO: 10041 Repair Type: Non-Urgent Crossing Status: Found UCIP Comments: 08/29/2016 Depressions cited previously are a make-shift staircase and not an indication of a problem with pipe. Pipe partiallay exposed on LS slope which should be backfilled. Crossing has been downgraded from Urgent to Non-Urgent. (K. Fazel - UCIP)01/10/2014 Depressions on both sides of the levee slope. It needs more investigation.Pump removed. (P. Amatya - DWR) FIELD_STRUCT_DESC: 8-inch steel irrigation discharge pipe through the levee, 4 feet below the crown. One corrugated metal cutoff wall. Pump and gate valve on a concrete pump platform on the riverbank. Corrugated metal switch house on the waterside (WS) slope. Meter pole on the WS shoulder. 8-foot by 6-foot, inside dimensions, concrete distribution box on the landside (LS). Overhead power line crosses the levee. Pole at the LS toe. Installed by USACE in 1952. (8-inch steel irrigation discharge pipe through the levee, pump, and all other appurtenances retained under Automatic Board Order (ABO) issued as Permit No. 10041, 1974 - William J. Duffy Jr.) [Additional Reference(s): DWR Levee Log, 2005. USACE Sacramento O&M Manual 128, March 1960, (HLM 11.57)]. FS Date: 8/29/2016

WS view: pipe, pump (removed), headwall, and appurtenances on river bank.

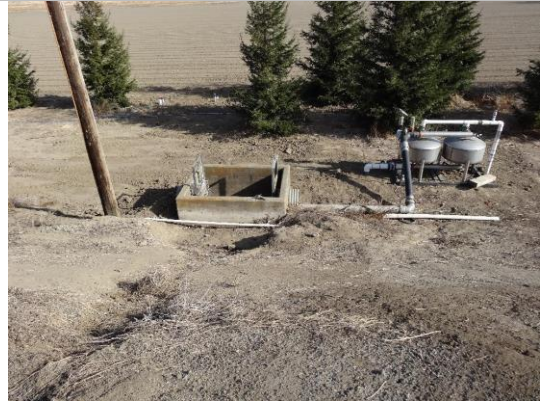
Photo 2 of 3 : UCIP\_SP\_2019\_50198\_52219.jpg

LS view: depressions along the pipe alignment on levee slope. It needs detailed investigation.

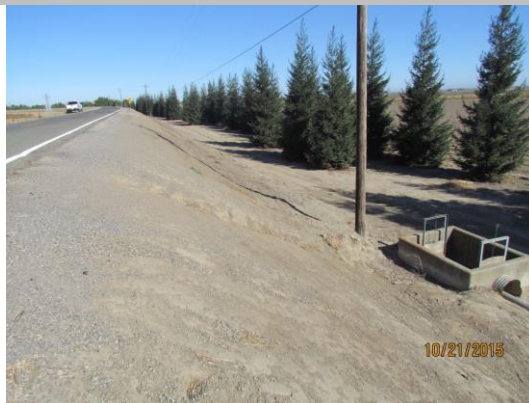
Photo 1 of 3 : SP\_2019\_RD1500\_189\_114\_20190304\_00055.jpg

LM Start	11.45	Rating **	M	Issue No.	114
LM End	11.45	Issue Type +	En	Location *	LS
Category	Earthen Levee			GPS Latitude/Longitude	
				Start	End
Item	Encroachments			38.868577 °	38.868577 °
				-121.746487 °	-121.746487 °
DWR ID	DWR_RD1500_01_f_2015_114				
Comment Code					
ST : Stairway					
Inspector Comment					
Landowner has dug stairs on the landside slope to irrigation equipment.

Perspective view of the concrete box on the landward side of the levee looking upstream. Fall 2015.

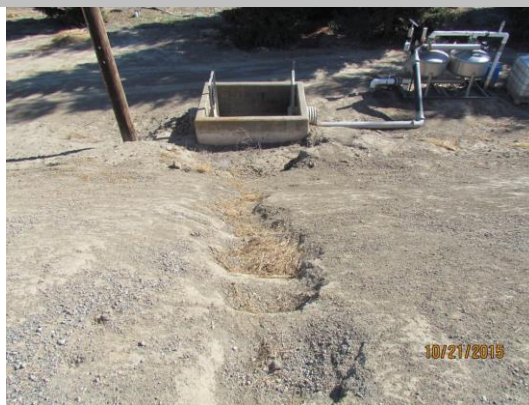
Photo 2 of 3 : SP\_2019\_RD1500\_189\_114\_20190304\_00056.jpg

There is erosion at the levee toe around the concrete box. There are also stairs leading down the slope. Fall 2015.

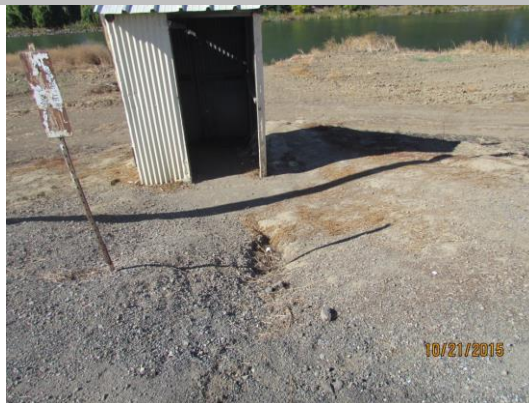
Photo 3 of 3 : SP\_2019\_RD1500\_189\_114\_20190304\_00057.jpg

There is slight erosion on the waterward side of the levee where the pipe seems to run through the levee. Fall 2015.

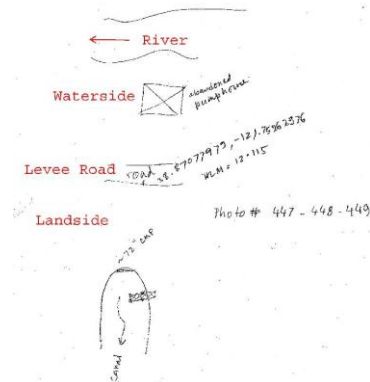
Photo 1 of 3 : UCIP\_SP\_2019\_41744\_51343.jpg

FS\_ID:41744  
DS\_ID:20008  
EP\_NO: N/A  
Repair Type: Non-Urgent  
Crossing Status: Indicator Found  
UCIP Comments: An abandoned pump house on waterside and a 72-inch corrugated metal pipe on landside. The pipe discharges into irrigation ditch (canal). Water was flowing during the field visit. Needs to verify from LMA whether this pipe is through the levee or not.  
FIELD\_STRUCT\_DESC: [State Ranch Bend Pumping Plant] 1 of 2: 36-inch by 42-inch reinforced concrete irrigation discharge culvert under the levee, 17 feet below the crown. Two concrete cutoff walls. Vertical pump on the riverbank. Slide gate on the waterside (WS) end. Wooden slide gate at the landside (LS) toe. Installed by USACE in 1947. (36-inch by 42-inch reinforced concrete irrigation discharge culvert under the levee, vertical pump, and all other appurtenances retained under Automatic Board Order (ABO) issued as Permit No. 10073, 1974 - Sutter Mutual Water Company, [Station 356+02]. To comply with Condition No. TWENTY of Board Order No. 9809 with plans to remove the old Pumping Plant No. 1 authorized under Permit No. 9809-A, 1976 - Sutter Mutual Water Company). [Additional Reference(s): DWR Levee Log, 1990. USACE Sacramento O&M Manual 128, March 1960, (HLM 12.12), two 48-inch by 42-inch concrete culverts referenced].

Sketch of Utility Crossing @HLM 12.115

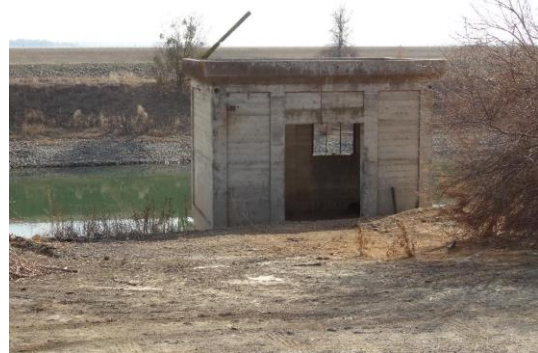
Photo 2 of 3 : UCIP\_SP\_2019\_41744\_51345.jpg

WS view: abandoned concrete pump house. No pump and pipe found.

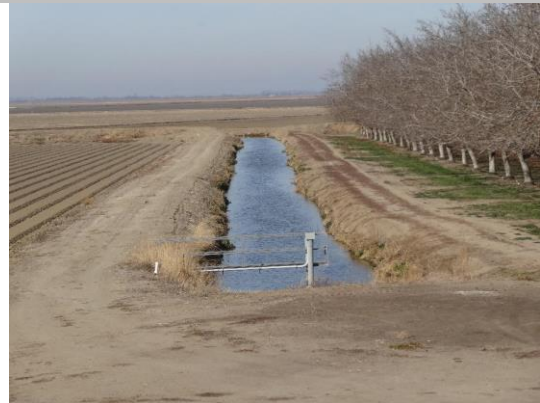
Photo 3 of 3 : UCIP\_SP\_2019\_41744\_51344.jpg

LS view: overview of irrigation ditch on toe of levee.

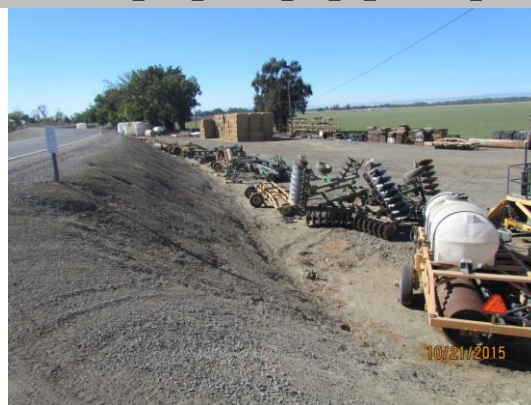
Photo 1 of 1 : SP\_2019\_RD1500\_189\_24\_20190304\_00010.jpg

LM Start	12.42	Rating **	M	Issue No.	24
LM End	12.53	Issue Type +	En	Location *	LS
Category	Earthen Levee			GPS Latitude/Longitude	
				Start	End
Item	Encroachments			38.868834 °	38.867492 °
				-121.760014 °	-121.760903 °
DWR ID	DWR_RD1500_01_s_2012_24				
Comment Code					
EQ : Equipment					
Inspector Comment

View of the equipment on the landward side of the levee looking upstream. Fall 2015.

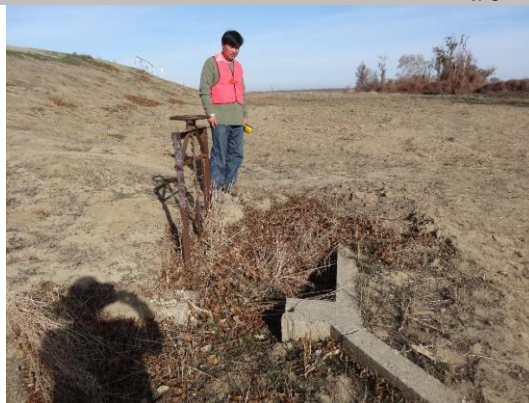
Photo 1 of 3 : UCIP\_SP\_2019\_50197\_52425.jpg

Comment Code						
Inspector Comment						
FS_ID:50197 DS_ID:20063 EP_NO: 10061 Repair Type: Non-Urgent Crossing Status: Found UCIP Comments: 08/29/2016 Same as last inspection. (K. Fazel - UCIP)01/10/2014 Needs proper abandonment. (P. Amatya - DWR) FIELD_STRUCT_DESC: *ABANDONED* 18-inch corrugated metal gravity drainage pipe through the levee, 15 feet below the crown. Slide gate in a 4-foot by 4-foot concrete box at the waterside (WS) toe. Concrete box at the landside (LS) toe. Pipe crosses overflow area to the river. Installed by USACE in 1944. (18-inch corrugated metal gravity drainage pipe through the levee and all other appurtenances retained under Automatic Board Order (ABO) issued as Permit No. 10061, 1974 - Roger L. Matteoli). [Additional Reference(s): DWR Levee Log, 2005. USACE Sacramento O&M Manual 128, March 1960, (HLM 12.69)]. FS Date: 8/29/2016

WS view: slide gate (left) in concrete box at levee toe. Slide gate and the box mostly burried.

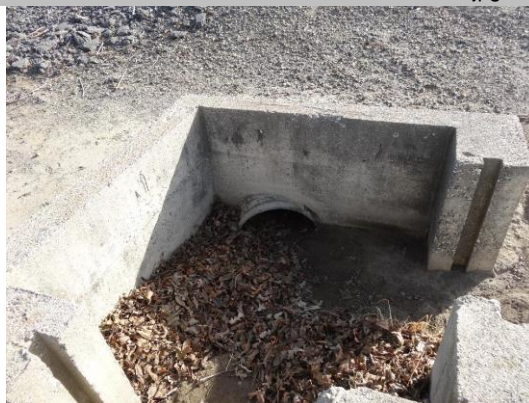
Photo 2 of 3 : UCIP\_SP\_2019\_50197\_52424.jpg

LS view: concrete intake box on levee toe.

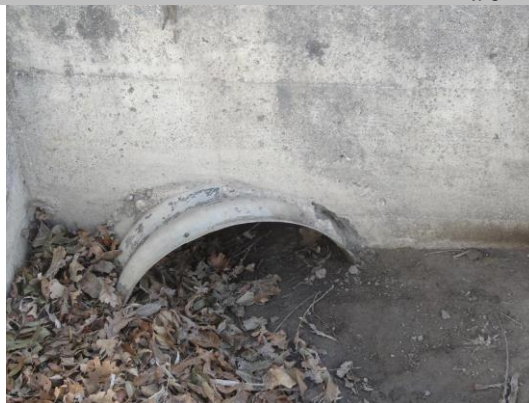
Photo 3 of 3 : UCIP\_SP\_2019\_50197\_52423.jpg

Item	DWR UCIP Field Study			38.867254 °	38.867254 °	
				-121.761212 °	-121.761212 °	
DWR ID	20063					
Comment Code						
Inspector Comment						
FS_ID:50197 DS_ID:20063 EP_NO: 10061 Repair Type: Non-Urgent Crossing Status: Found UCIP Comments: 08/29/2016 Same as last inspection. (K. Fazel - UCIP)01/10/2014 Needs proper abandonment. (P. Amatya - DWR) FIELD_STRUCT_DESC: *ABANDONED* 18-inch corrugated metal gravity drainage pipe through the levee, 15 feet below the crown. Slide gate in a 4-foot by 4-foot concrete box at the waterside (WS) toe. Concrete box at the landside (LS) toe. Pipe crosses overflow area to the river. Installed by USACE in 1944. (18-inch corrugated metal gravity drainage pipe through the levee and all other appurtenances retained under Automatic Board Order (ABO) issued as Permit No. 10061, 1974 - Roger L. Matteoli). [Additional Reference(s): DWR Levee Log, 2005. USACE Sacramento O&M Manual 128, March 1960, (HLM 12.69)]. FS Date: 8/29/2016

LS view: silted CMP in concrete intake box on levee toe.

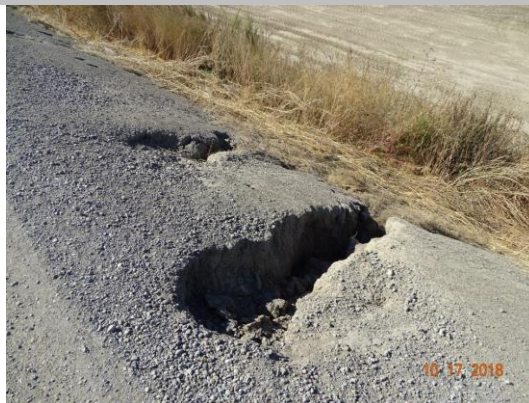
Photo 1 of 2 : SP\_2019\_RD1500\_189\_118\_20190304\_00060.jpg

LM Start	12.57	Rating **	U	Issue No.	118
LM End	12.57	Issue Type +	Ma	Location *	WS
Category	Earthen Levee			GPS Latitude/Longitude	
				Start	End
Item	Erosion / Bank Caving			38.867108 °	38.867108 °
				-121.761498 °	-121.761498 °
DWR ID	DWR_RD1500_01_f_2015_118				
Comment Code					
E2 : Schedule repair of erosion site prior to the next inspection.					
Inspector Comment					
Recommend backfilling erosion.

Updated view of erosion on the landside slope. Fall 2018.

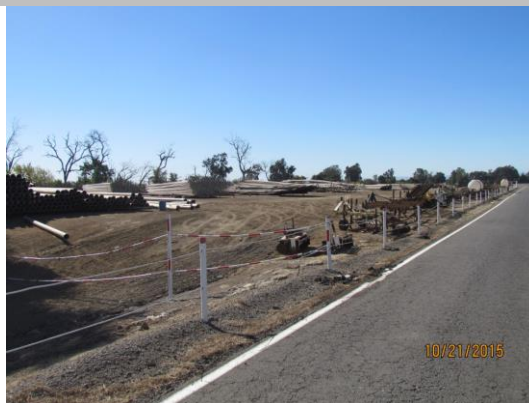
Photo 1 of 1 : SP\_2019\_RD1500\_189\_25\_20190304\_00011.jpg

LM Start	12.78	Rating **	M	Issue No.	25
LM End	12.86	Issue Type +	En	Location *	WS
Category	Earthen Levee			GPS Latitude/Longitude	
				Start	End
Item	Encroachments			38.865429 °	38.864777 °
				-121.764684 °	-121.765857 °
DWR ID	DWR_RD1500_01_s_2012_25				
Comment Code					
EQ : Equipment					
Inspector Comment

View of the equipment on the waterside shoulder of the levee looking upstream. Fall 2015.

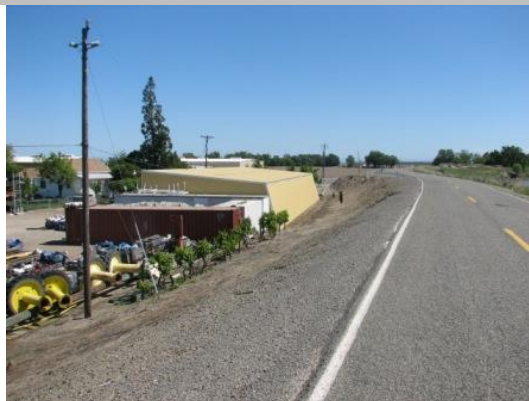
Photo 1 of 1 : SP\_2019\_RD1500\_189\_26\_20190304\_00012.jpg

LM Start	13.01	Rating **	M	Issue No.	26
LM End	13.01	Issue Type +	En	Location *	LS
Category	Earthen Levee			GPS Latitude/Longitude	
				Start	End
Item	Encroachments			38.863438 °	38.863438 °
				-121.768212 °	-121.768212 °
DWR ID	DWR_RD1500_01_s_2019_26				
Comment Code					
BU : Building					
Inspector Comment

The building's backside was built into the toe of the levee.
